NHC Ref. No. 03000276

21 November 2014

Re: Lazo Road Shoreline Protection

**Wave Climate Assessment**

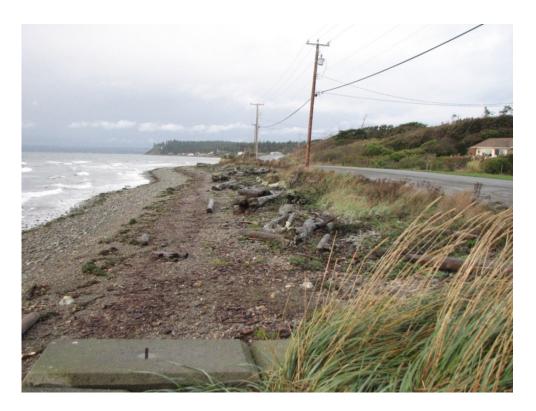
Photo 1: Viewing south, top of road el. = 3.8m, base of backshore el. 2.8m, WL = 1.0 m CGD (approximately).

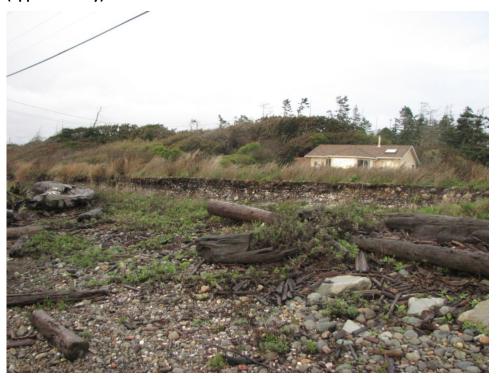
Photo 2 (4079): Midden site, top of berm is at approximately elevation 3.5m CGD.

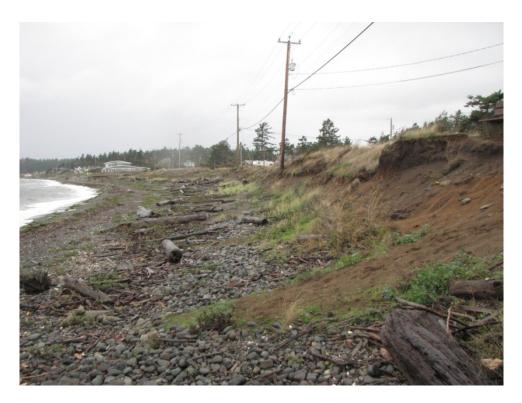
Photo 3 (4087): Top of berm el. = 5.4m; base of slope el. = 3.0m; ocean level = 1.3m CGD

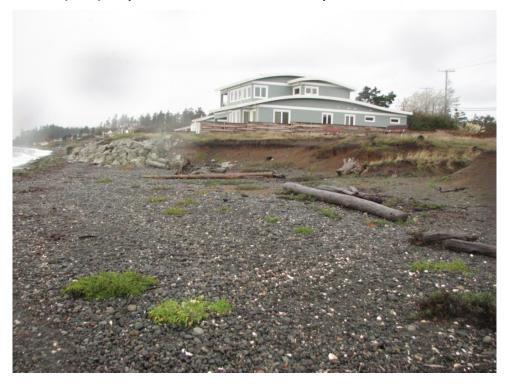
Photo 4 (4086): Top of berm el. = 4.5m; top of riprap el. = 3.5m; ocean level = 1.3m CGD
