# SITE SERVICING REPORT – REV. 1

Site Servicing Report for 721 Lazo Road in  
Support of Development Permitting

Parcel B (DD 20772N) of District Lot 191, Comox  
District, 721 Lazo Road, Comox, BC

Rev. 1 Issued for Permitting and Rezoning

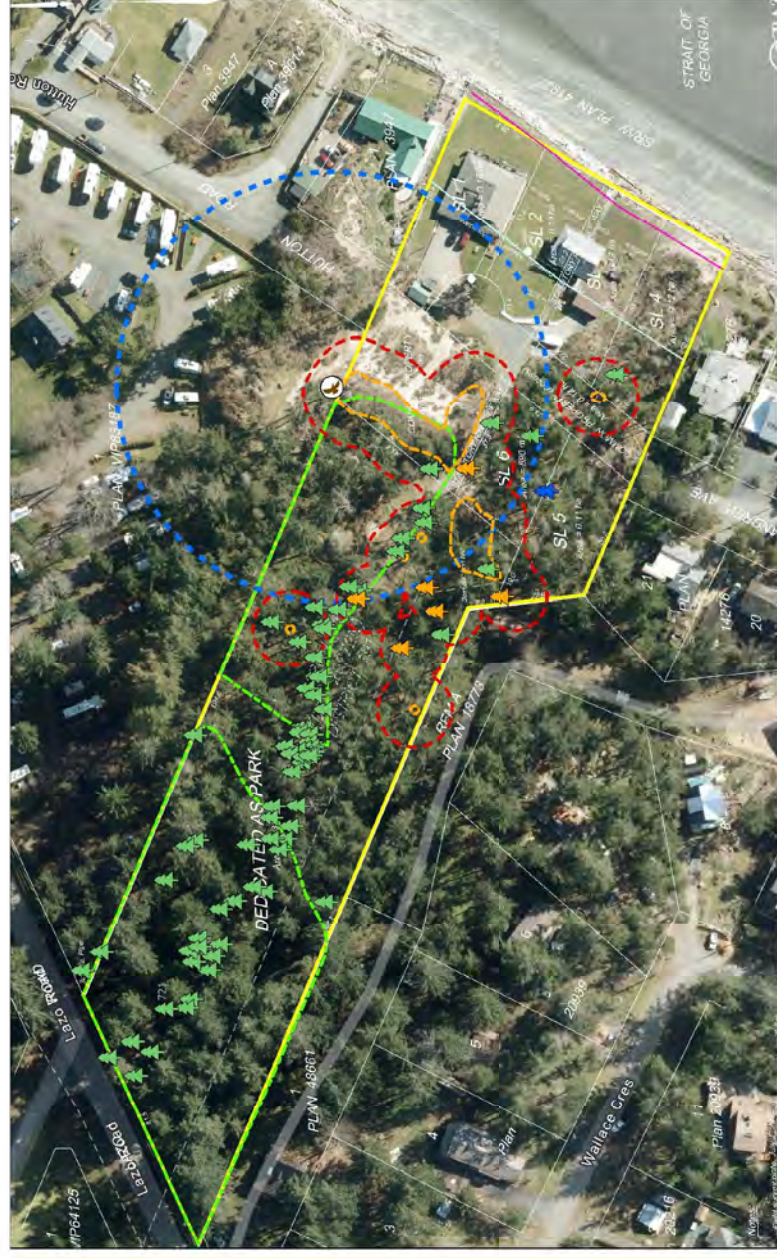
**Figure 1.** Map of the bare land strata subdivision of Parcel B of District Lot 101 at 721 Lazo Road, Town of Comox. Map showing the identified sensitive environmental features, associated setbacks, and proposed subdivision lines based on the engineering plans dated June 5th, 2025. \*It should be noted not that all mature trees on the subject lot were documented, but rather, the mature trees within the proposed development footprint. All linework is approximate. \*

One eagle nest was located on an adjacent property north of the subject lot, approximately 3m from the property boundary. The nest was located in a mature Douglas fir tree and was observed to be active (Figure 1; Photo 8 & 9) (10U, 364408.55 m E, 5505361.45 m N). Two adult Bald eagles (*Haliaeetus leucocephalus*) and two eaglets were observed to be in the nest during the May 2025 assessment, with white wash, bones, and feathers observed at the base of the tree (Photo 10). No additional raptor nests were identified during the survey, however, a mature Douglas fir perch tree was identified (10 U 364375.58 m E, 5505296.48 m N) and was utilized by an eagle during the assessment (Photo 11).

approximately 100m to 200m southeast of Lazo Road (Figure 1). The areas identified as potential older forest contained several standing snags, fallen trees and stumps. The average DBH of trees within the forested area on the lot was approximately 0.9m. However, some Douglas fir trees with a DBH of 4.0m were observed. Although forest within the identified polygons may consist of mixed-age class trees, these areas contain a greater proportion of older trees, as well as components that contribute to structural complexity and variable canopy closure associated with environmental values such as high wildlife values and specialized habitats of older forest ecosystems.

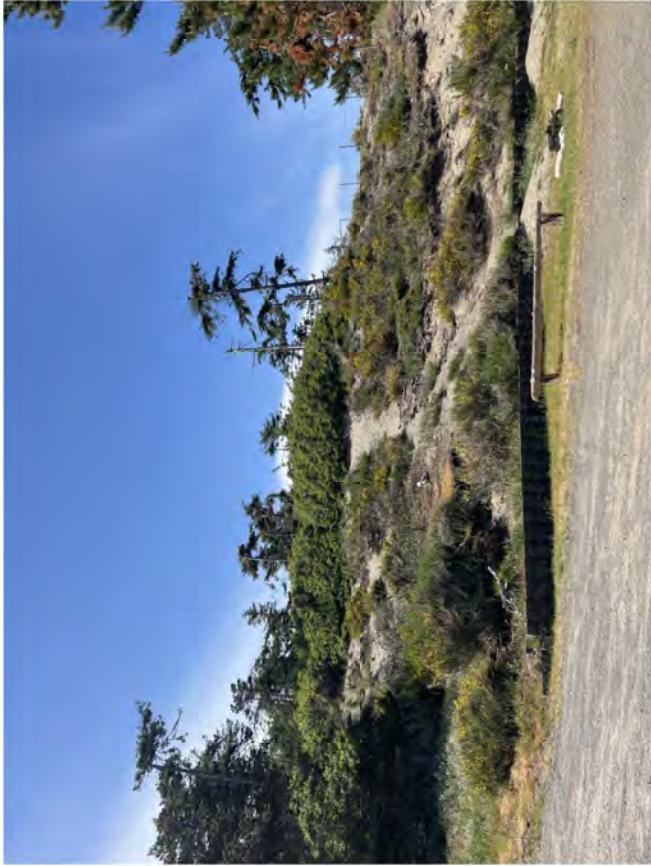
**Photo 3. May 28th, 2025.** Photo showing the largest Garry Oak stand, Stand 1, located at the top of the sandy slope.

The Garry oak trees and stands located throughout the lot, ranged in size from sapling to large mature trees. The large stand, Stand 1, consisted primarily of krumholz Garry Oaks, with a few large mature trees along the ridge of a sandy slope and extending east for approximately 10m down the slope, and 25m along the driveway (Photo 6). The krumholz trees were short (1-2m height) and grew in close proximity to each other (Photo 7). The krumholz Garry Oaks were assessed to determine the total number of trees within the stand, specifically, the number of individuals and stems. There were determined to be approximately two individuals, one with 180 stems and the other with 290 stems. For the purposes of this assessment, an individual is defined as an entire root system that is connected, and the stems are small individual trunks or shoots that all grow from that root system. However, it is recommended that a certified ISA arborist assess these stands to provide a definitive count. Understory vegetation was minimal and consisted of grass, bracken fern (*Pteridium aquilinum*) and scotch broom. Spare self-heal (*Prunella vulgaris*) was observed growing on the sandy slope. Other Garry Oak meadow associated species were not noted at the time of this assessment. The other Garry Oak stands and trees on the subject property were observed within a mixed stand, primarily consisting of Douglas fir trees (*Pseudotsuga menziesii*). Understory vegetation consisted primarily of salal (*Gaultheria shallon*), dull Oregon-grape (*Mahonia nervosa*), Nootka rose (*Rosa nutkana*), Bracken fern (*Pteridium aquilinum*), sword fern (*Polystichum munitum*), and grass, similar to the understory vegetation found throughout the subject property. Garry oak meadow associated species were not identified during the assessment.

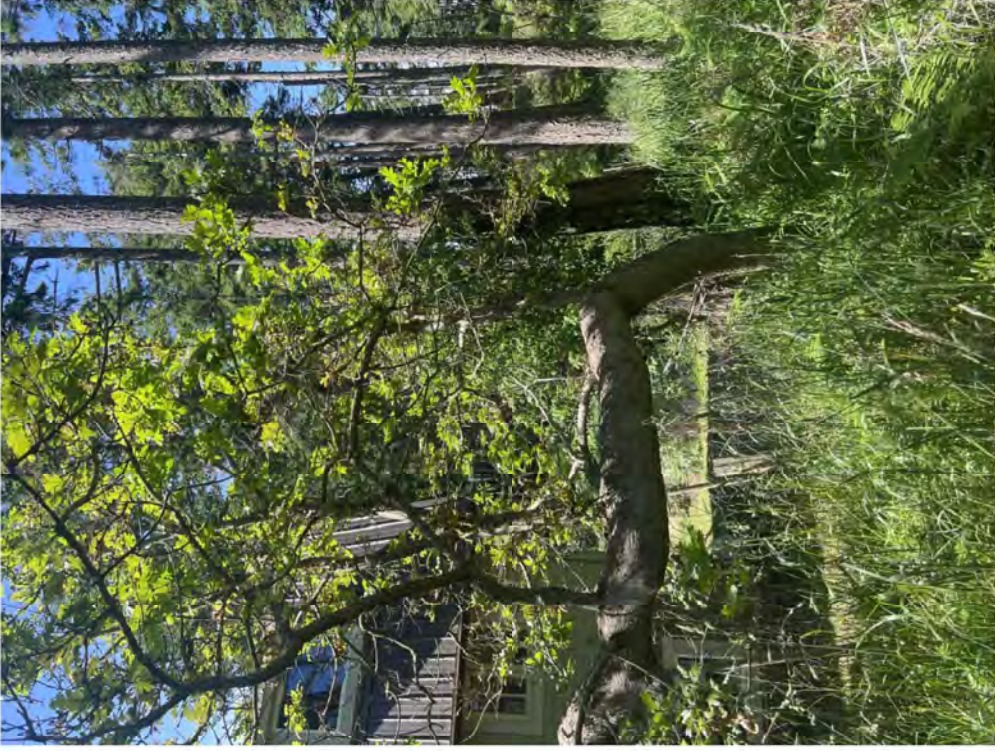
**Photo 4. May 28th, 2025.** Photo showing one of the individual Garry Oak trees identified on the subject property, located in the SL 5 parcel.

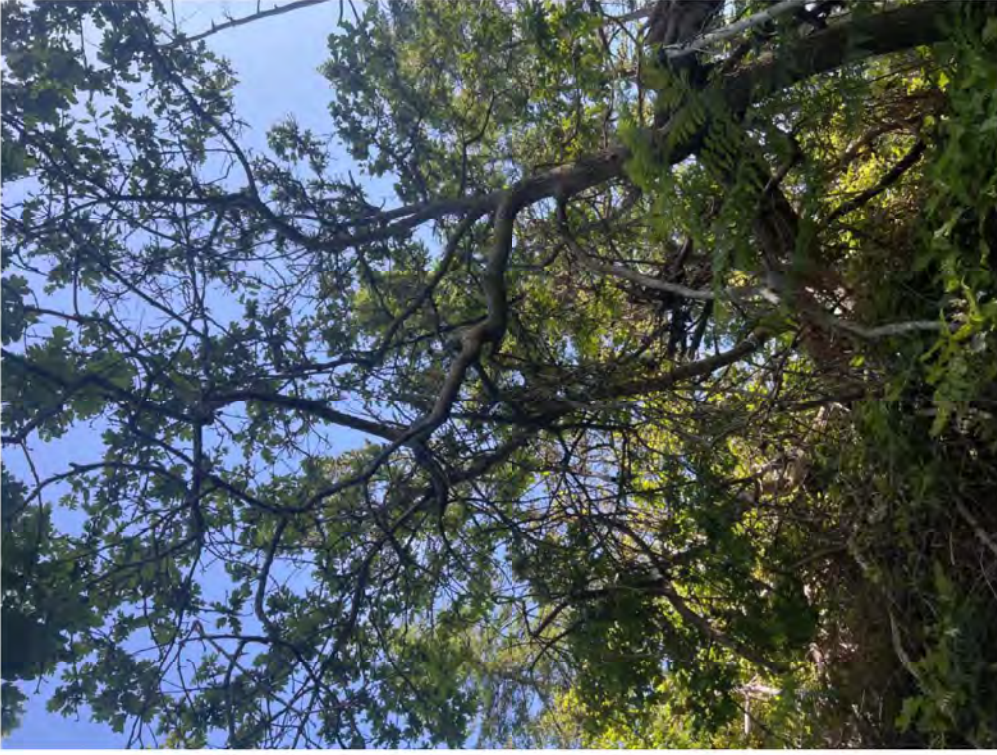
**Photo 5. May 28th, 2025.** Photo showing the Stand 6, located within the proposed 0.12ha common property access parcel.

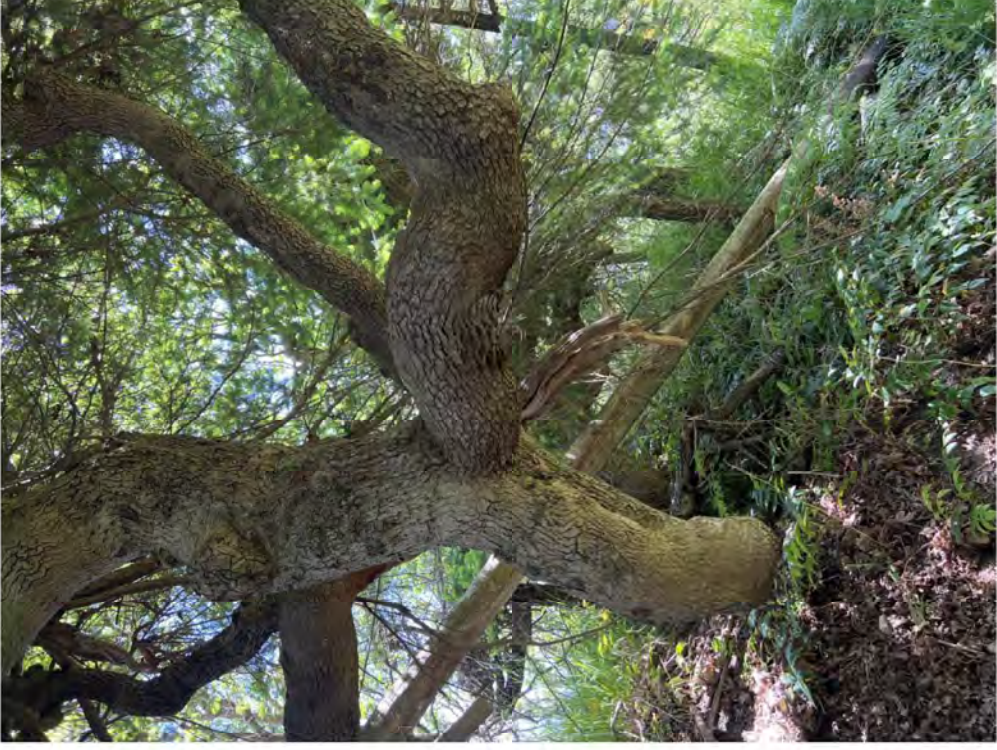
**Photo 6. May 28th, 2025.** Photo showing a mature Garry Oak within Stand 1, located on the ridge of the sandy slope.

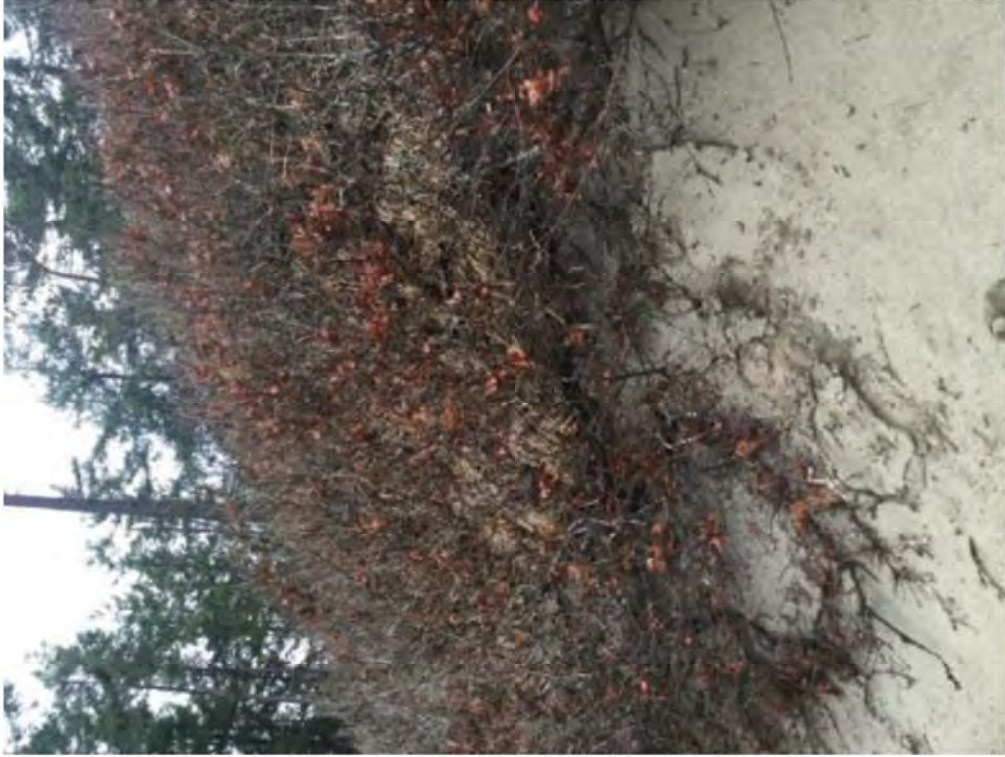
**Photo 7. January 28th, 2020.** Photo showing the Krumholz Garry oaks identified on the subject property.

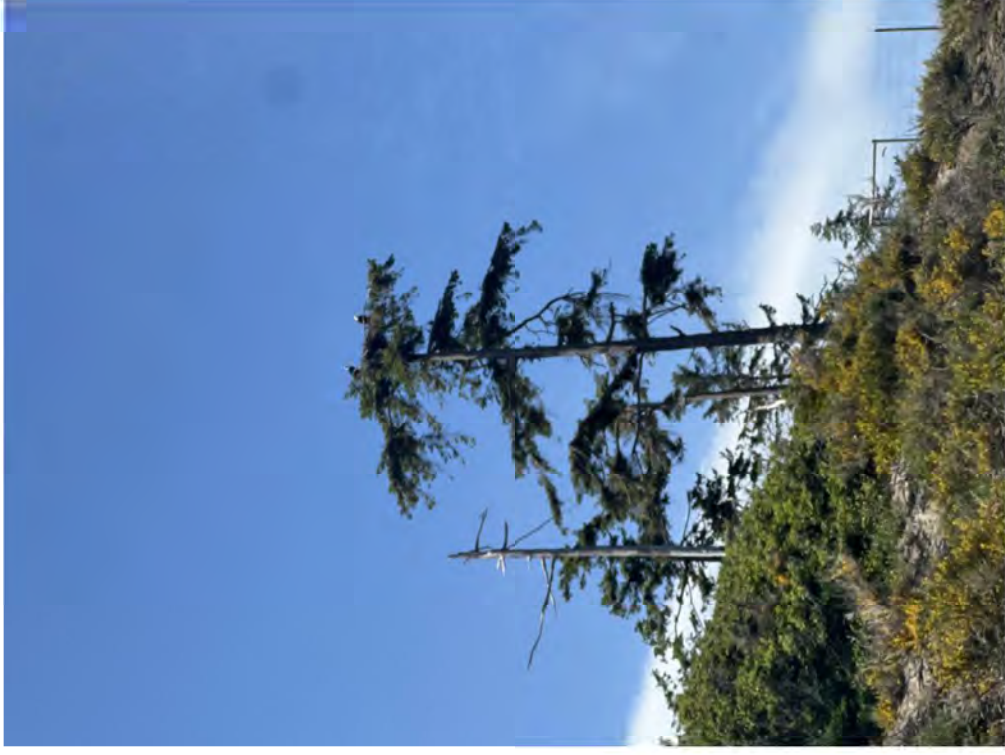
**Photo 8. May 28th, 2025.** Photo showing the active bald eagle nest identified on an adjacent property, approximately 3m north of the subject property.

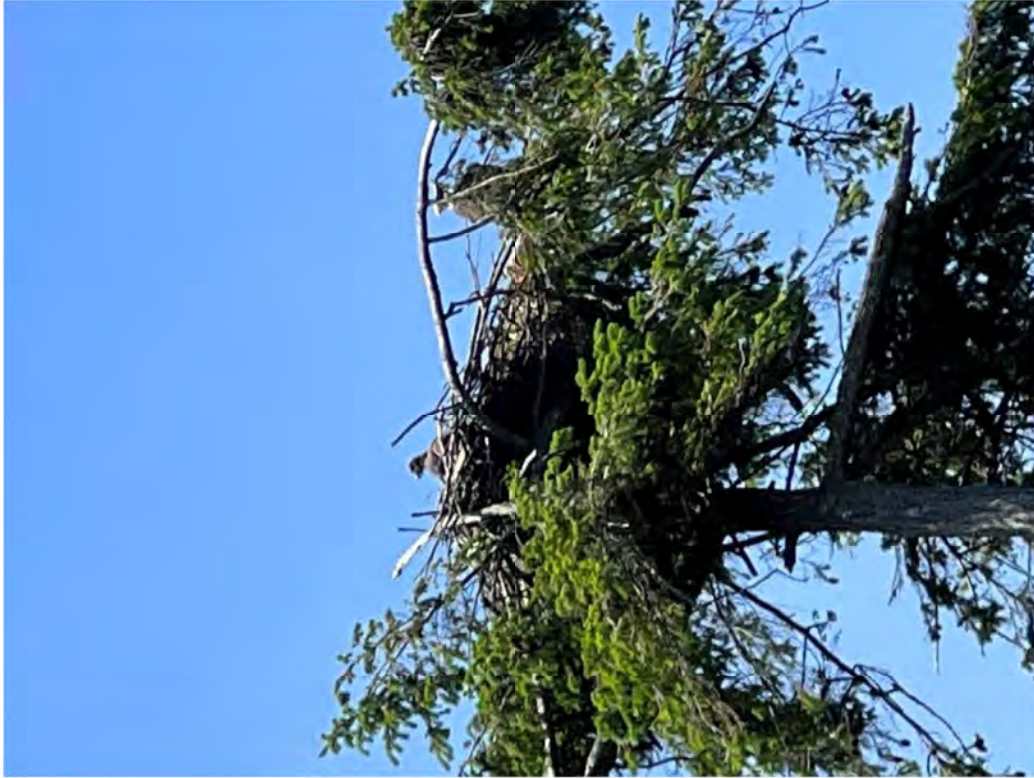
**Photo 9. May 28th, 2025.** Photo showing the bald eagle nest with one of the eaglets and a parent sitting within the nest.

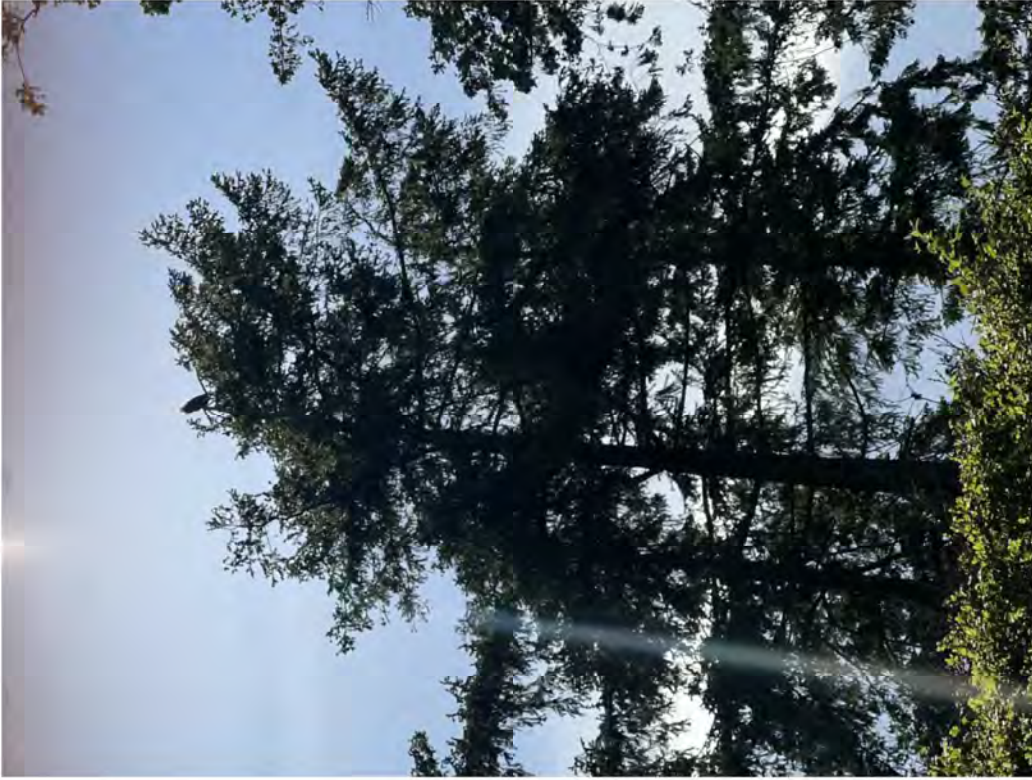
**Photo 11. May 28th, 2025.** Photo showing the perch tree identified on the subject property, with an eagle observed to be actively using the tree.

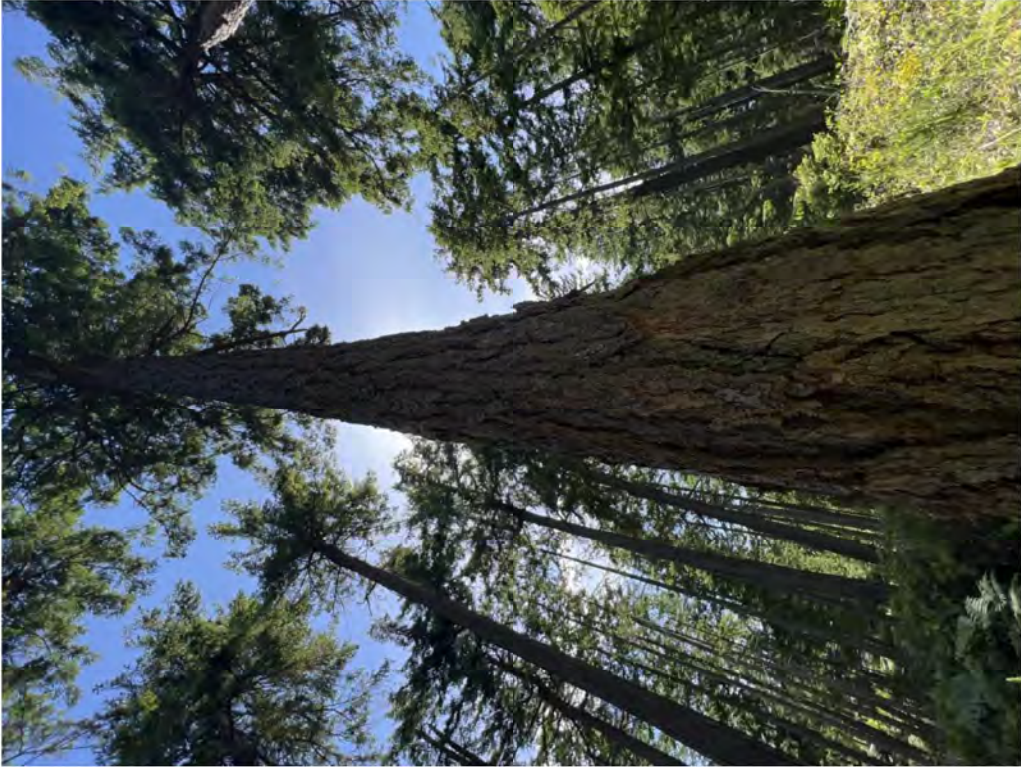
**Photo 13. May 28th, 2025.** Photo showing an older Douglas fir with characteristics of a potentially older tree.

Much of the assessed property consists of mature coniferous forest, a significant portion of which has potential to be considered older forest (average age of tree >100 years<sup>11</sup>). Areas that were identified as potential older forest were indicated by a majority of trees having soft flaky bark or hard bark with deep fissures, branch stubs replaced by knot or whorl indicators, and small to large epicormic branches (Photo 12)<sup>12</sup>. Potential older forest identified at this site consisted primarily of Douglas fir (Photo 13 & 14) and was located on the northwestern portion of the property, extending from the road approximately 75m southeast, and north of the driveway extending from

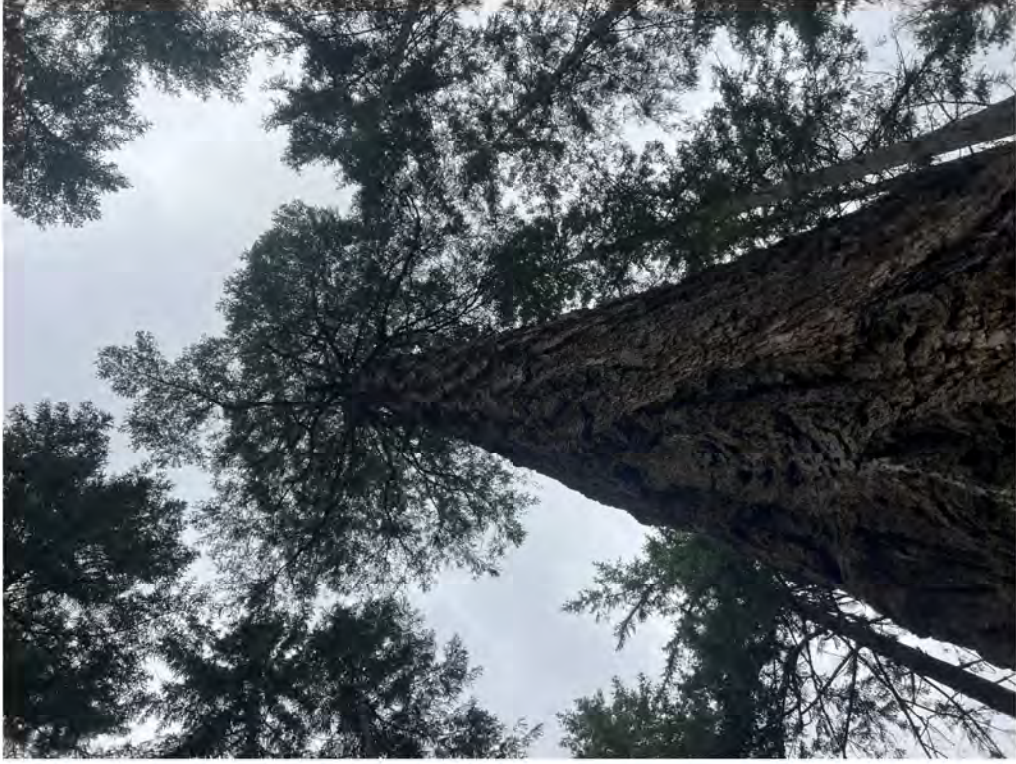
**Photo 14. November 14<sup>th</sup>, 2025.** Photo showing an older Douglas fir with characteristics of a potentially older tree.

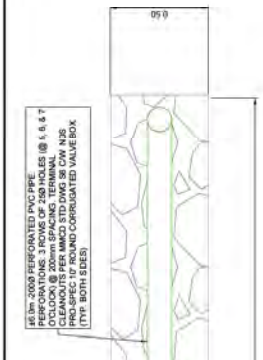
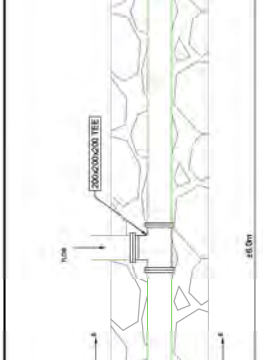
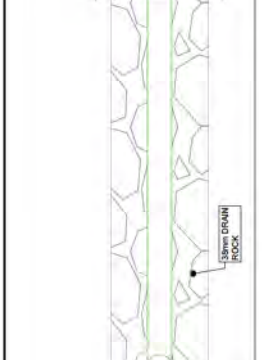
436 DISPERSION TRENCH CROSS-SECTION (DETAIL)

437 DISPERSION TRENCH (ELEVATION)

- Install a dispersion trench near the 15m setback from the present natural boundary. The dispersion trench will allow for infiltration into the soil of any flows that leave the storage unit, as well as allow for the trench to backup and discharge to the surface. Once on the surface, flows will sheet flow towards the Straight of Georgia. The preliminary design is for a 6m long dispersion trench; the size and design may change at time of detailed design.

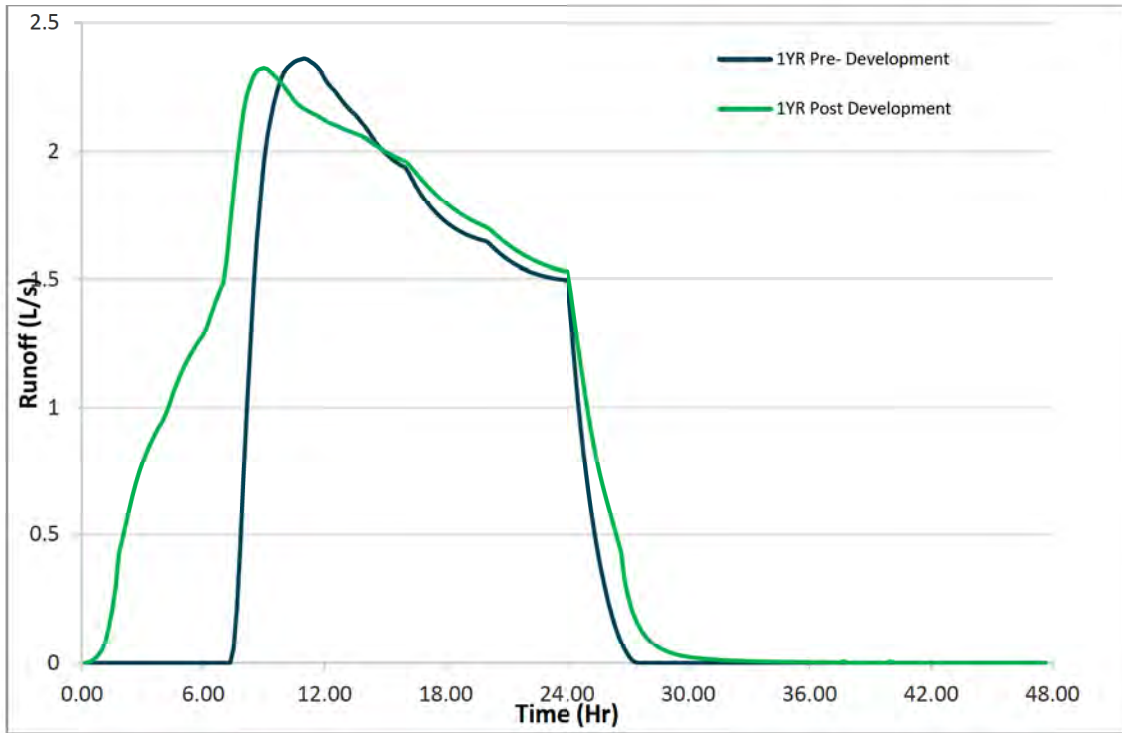
Figure 1: 1-Year Design Rainfall Event Pre-Development and Post Development Runoff

**Table 4** below compares pre-development and post-development simulated runoff for the site. The analysis shows that with the use of the listed stormwater management methods and BMP's listed above in **Section 4.3**, runoff can be detained and released with peak rates at or below existing up to the 25-year design storm. Please see **Appendix D: Pre-Development and Post Development Runoff Graphs** for illustration of this table.

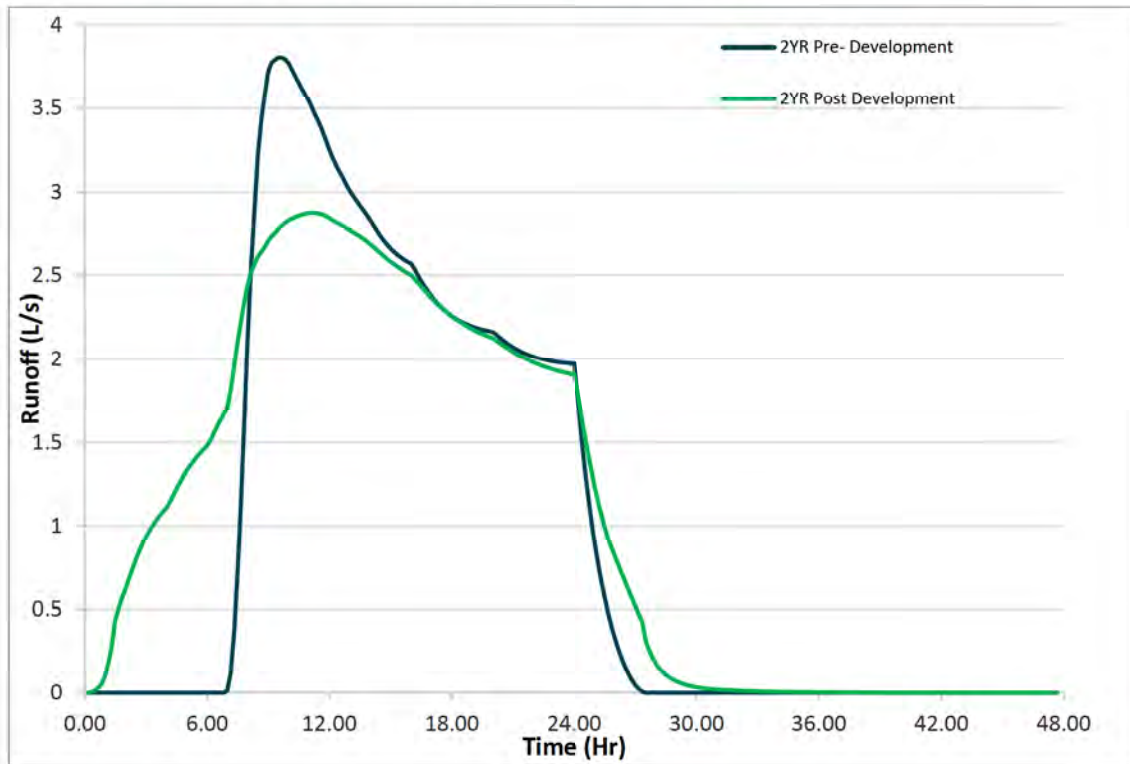
Figure 2: 2-Year Design Rainfall Event Pre-Development and Post Development Runoff

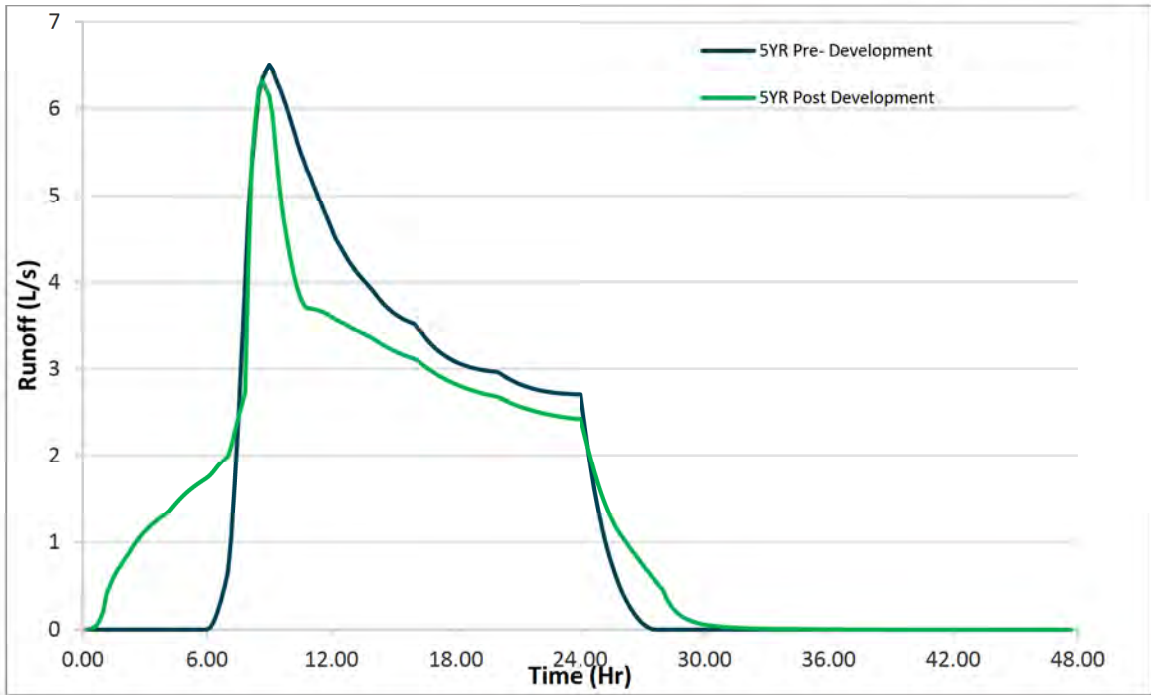
Figure 3: 5-Year Design Rainfall Event Pre-Development and Post Development Runoff

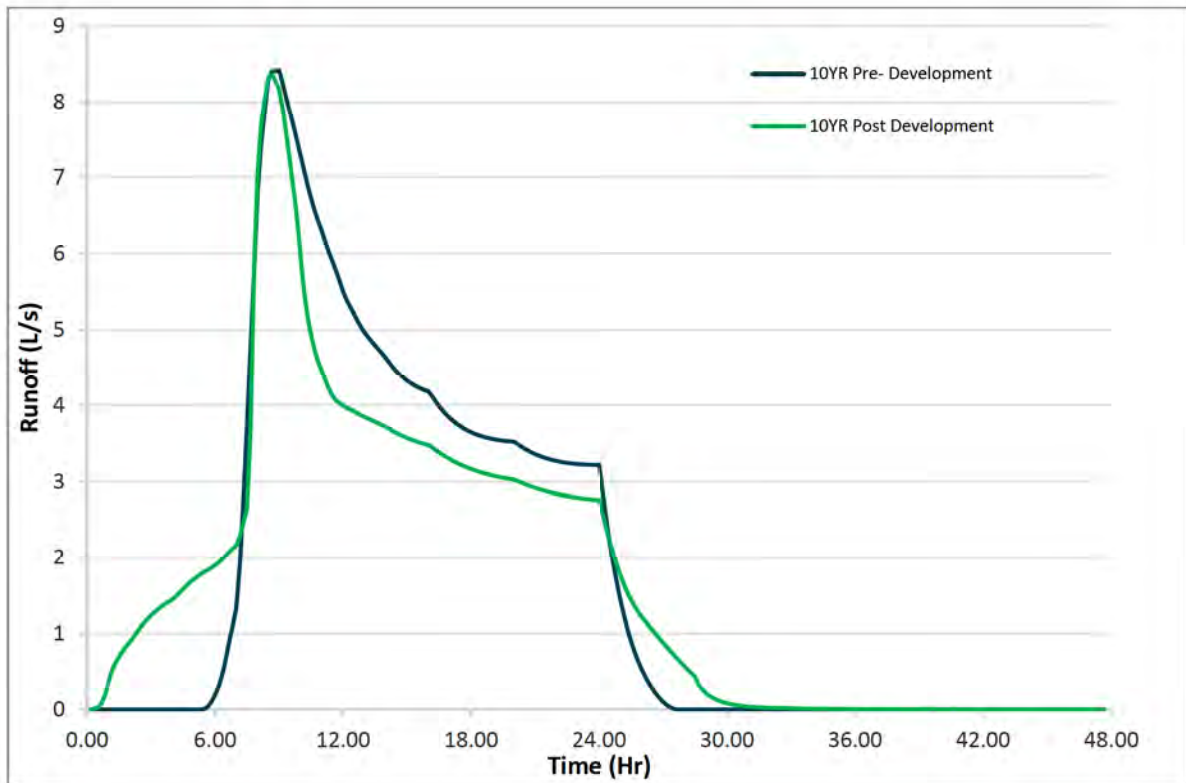
Figure 4: 10-Year Design Rainfall Event Pre-Development and Post Development Runoff

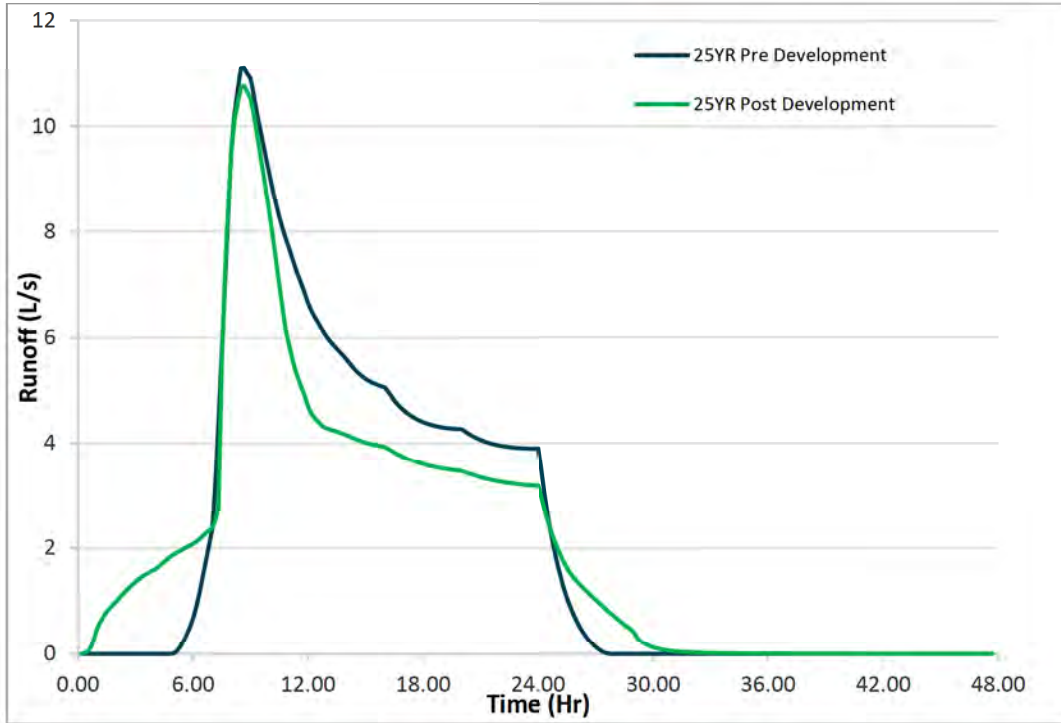
Figure 5: 25-Year Design Rainfall Event Pre-Development and Post Development Runoff

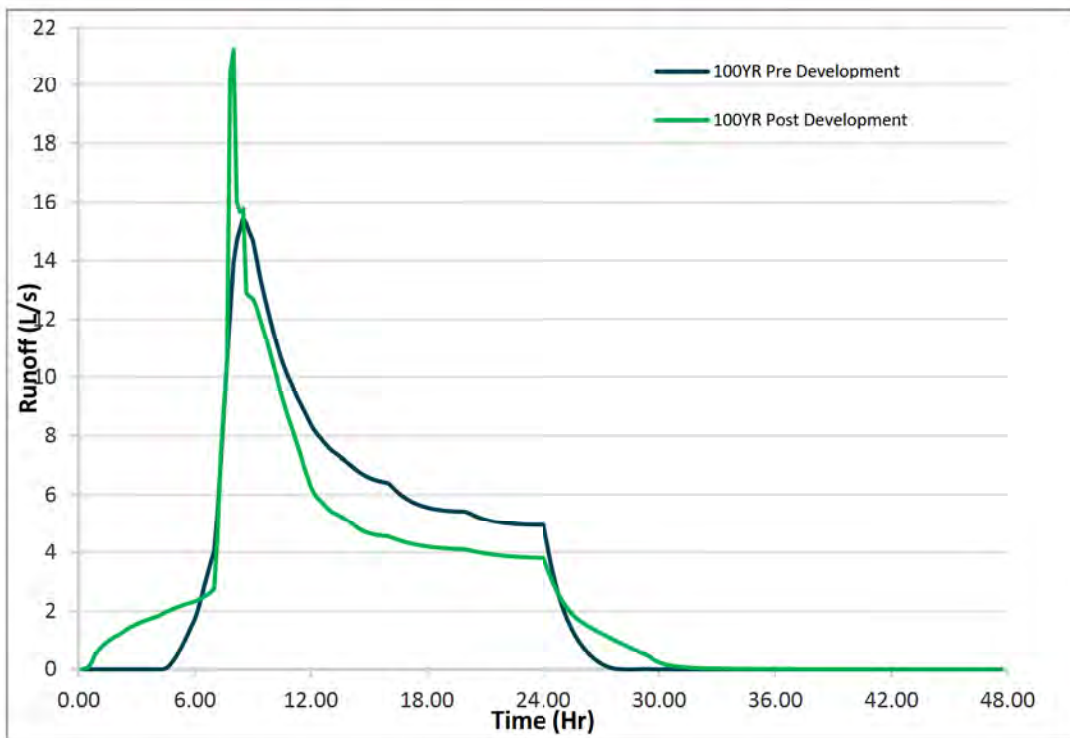
Figure 6: 100-Year Design Rainfall Event Pre-Development and Post Development Runoff
